House at Orchard Barn, Ringshall, Suffolk

An Historical Survey

**Leigh Alston MA (Oxon)
Architectural Historian
4 Nayland Road
Bures St Mary
Suffolk CO8 5BX**

March 2007

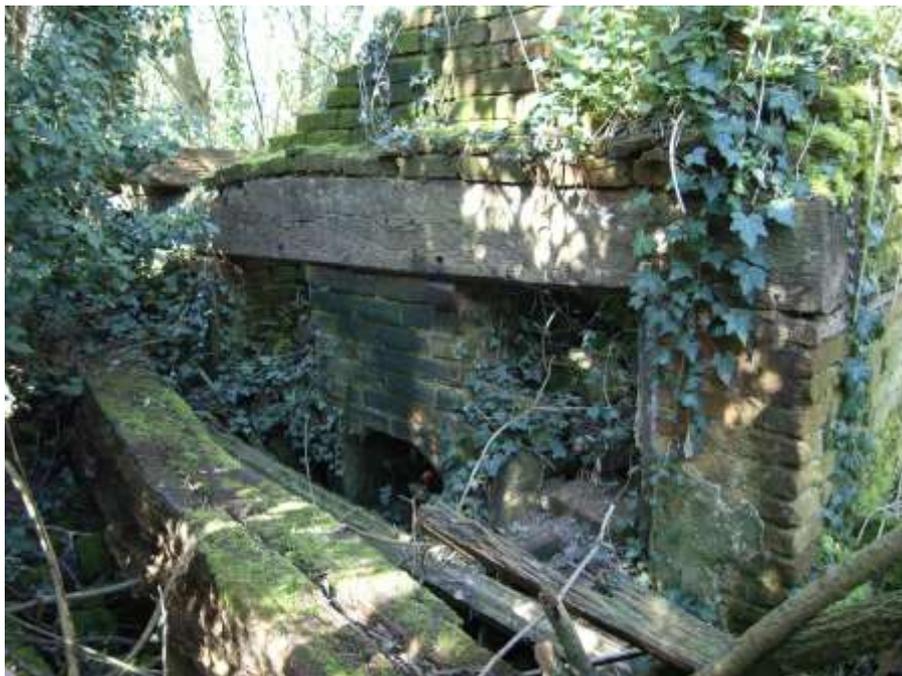
Illus. 1 The intact 16th or early-17th century fireplace, extending to 9½ feet in width

A large south-facing brick fireplace adjoins the western wall of the window-less northern bay shown in figure 1. Despite the insertion of a smaller fireplace in the 19th century its original brick piers and timber lintel remain intact, albeit exposed to the elements. The chimney breast also survives, although the superstructure of the chimney has fallen. This fireplace is 9 feet 6 inches in width and is an impressive and remarkable survival under the circumstances. It may well be contemporary with the structure, but is possibly an addition of the early-

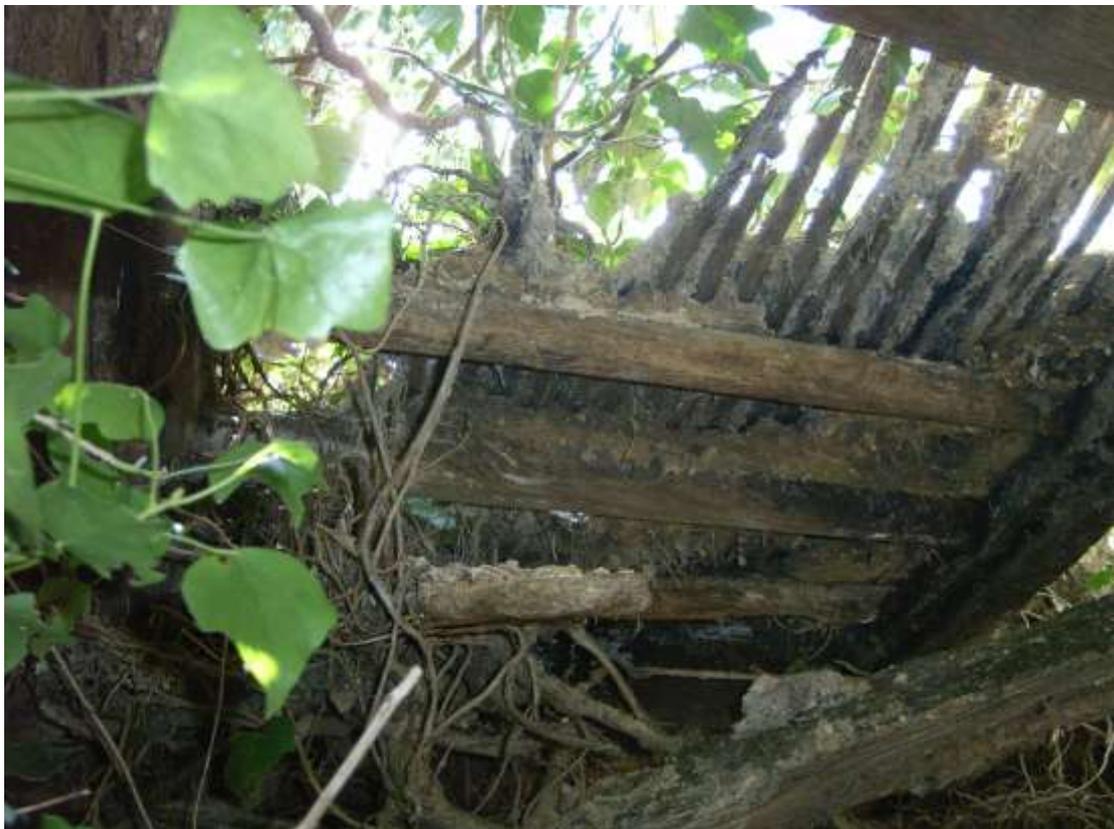
Illus. 2 The original window of 'diamond' mullions in the western elevation, with three intact mullions now lying horizontally (rebated sill to right).

of four unglazed windows containing 'diamond' mullions (i.e. square mullions set diagonally in typical 16th century fashion), each of which was closed by internal shutters sliding in grooves. Three of the four original mullions in the right-hand first-floor window remain *in situ*, having been blocked by external lath-and-plaster at an early period. There is evidence that the entire frame was until recently hidden by secondary external render, although most has now rotted away, but small areas of original wattle-and-daub still remain between the studs.

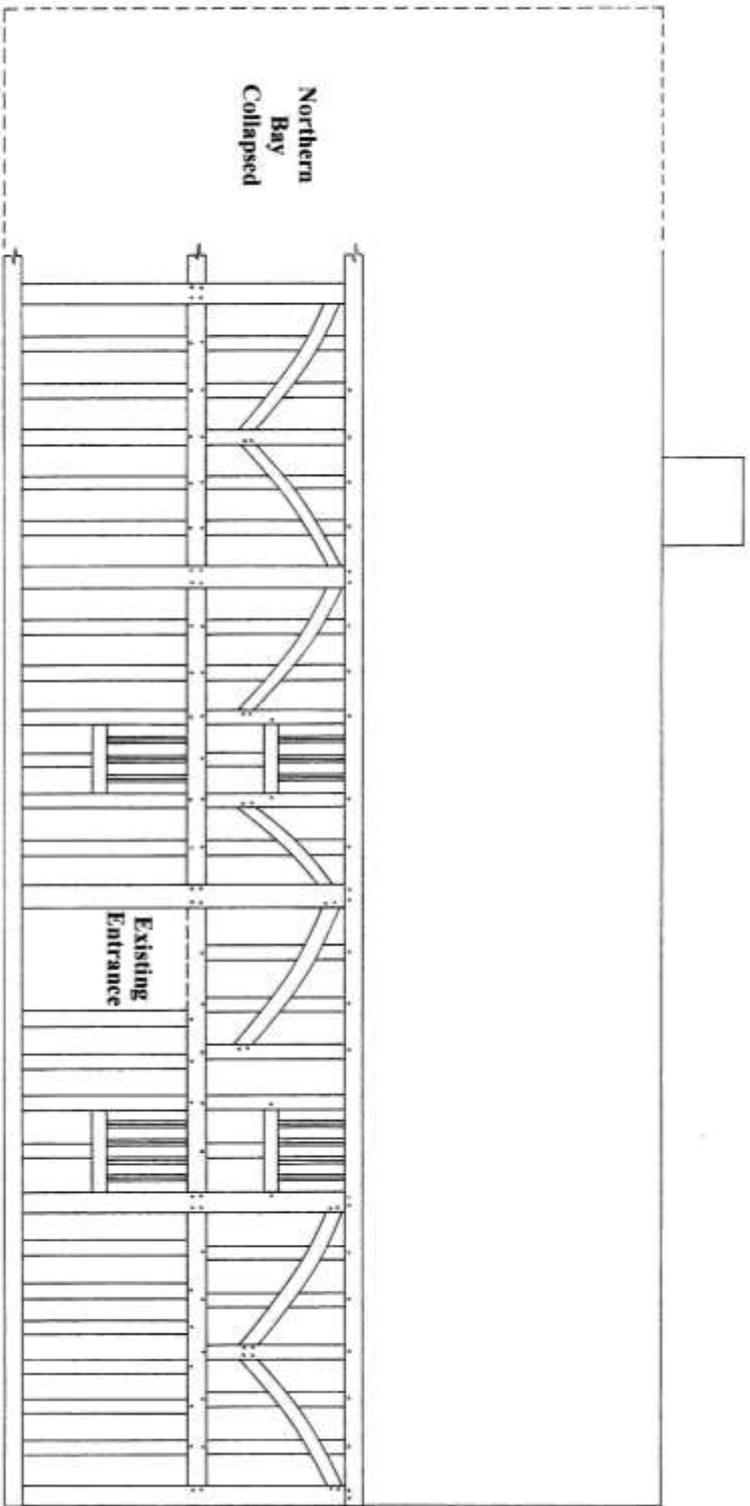
House at Orchard Barn, Bildeston Road, Ringshall
Front (Western) External Elevation
Reconstruction

condition, most timbers remain solid and are still jointed to the frame. Figure 1 shows a reconstruction of this western façade, where the great majority of the components either remain *in situ* or are lying nearby. The upper storey incorporates a series of externally trenched wall braces that were designed to be visible and form an elegant pattern that would have been perfectly at home

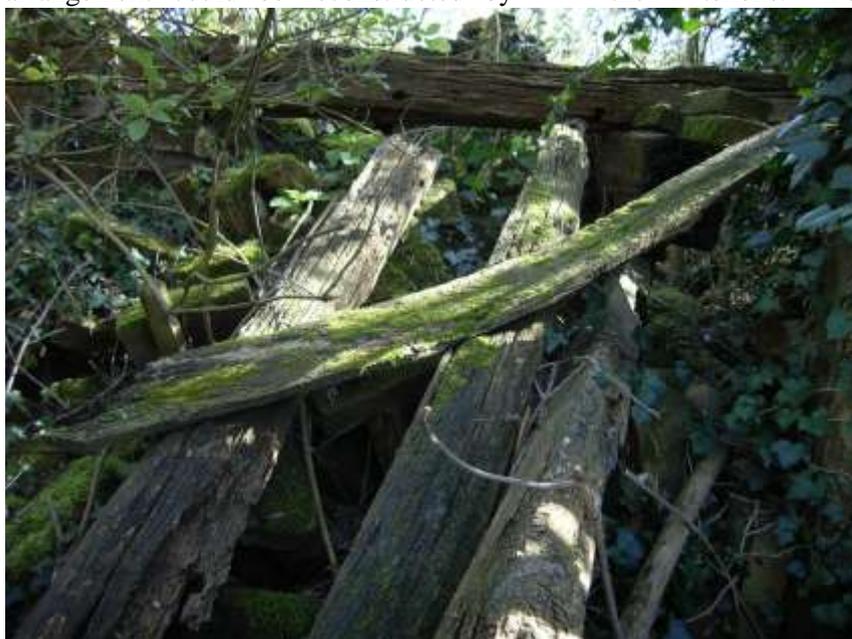
Illus. 3 An external wall brace in the western elevation, still trenched across the studs despite its precarious angle.

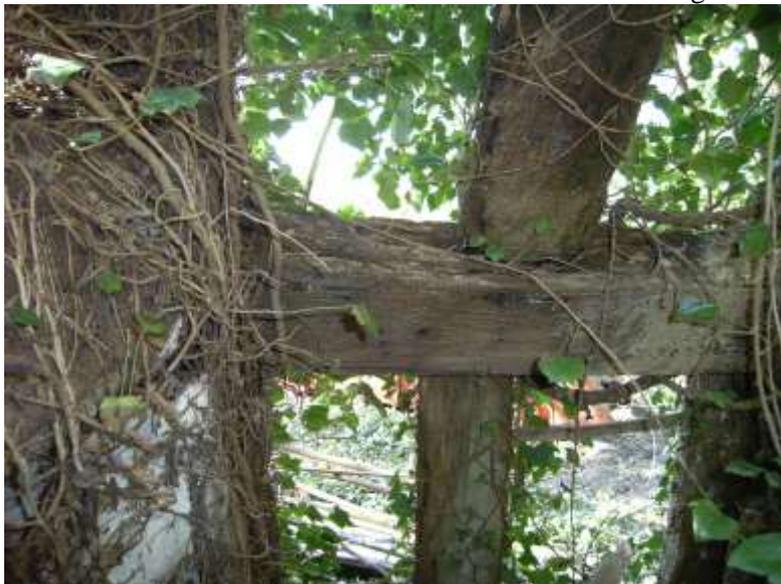
Illus. 4 The south-western corner of the later hall, showing intact mid-rail and studs with secondary cross-passage screen to left.

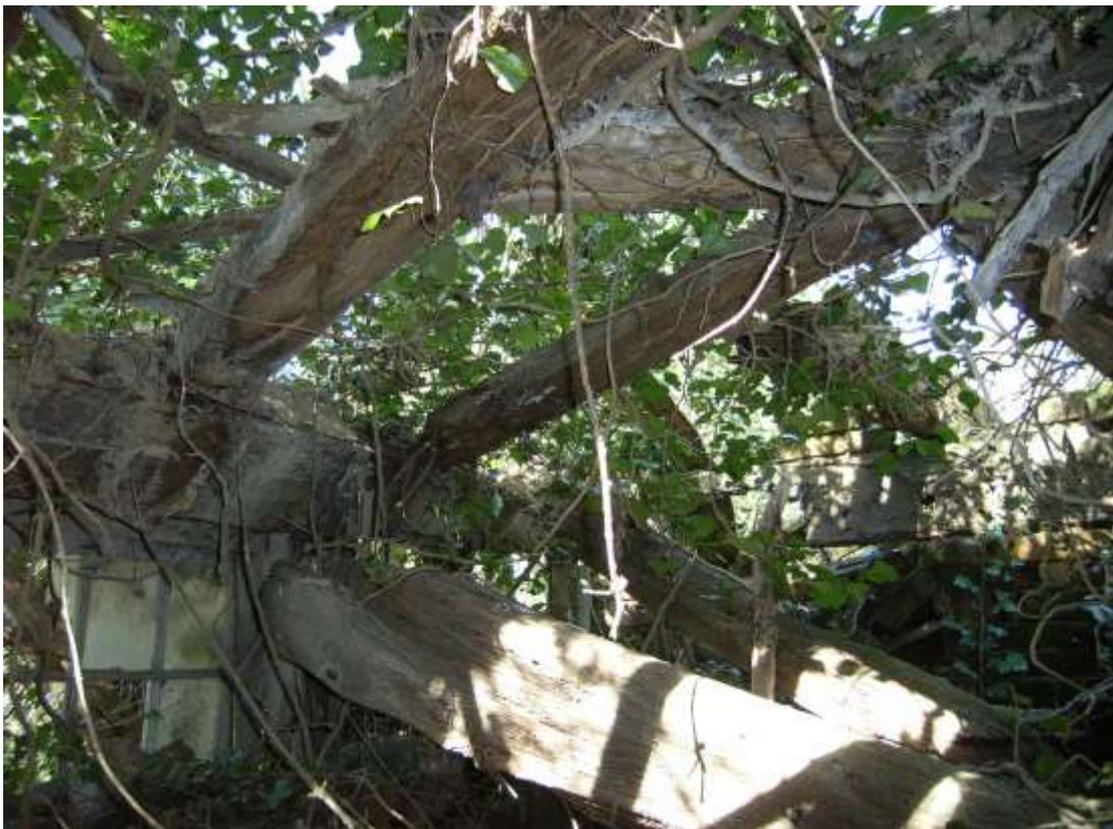
Illus. 5 The interior of the hall, showing the western elevation with first-floor studs and wall brace overhead (the principal fireplace visible to the right). Note the horse shoe suspended from the mid-rail above the 19th century glazed window.

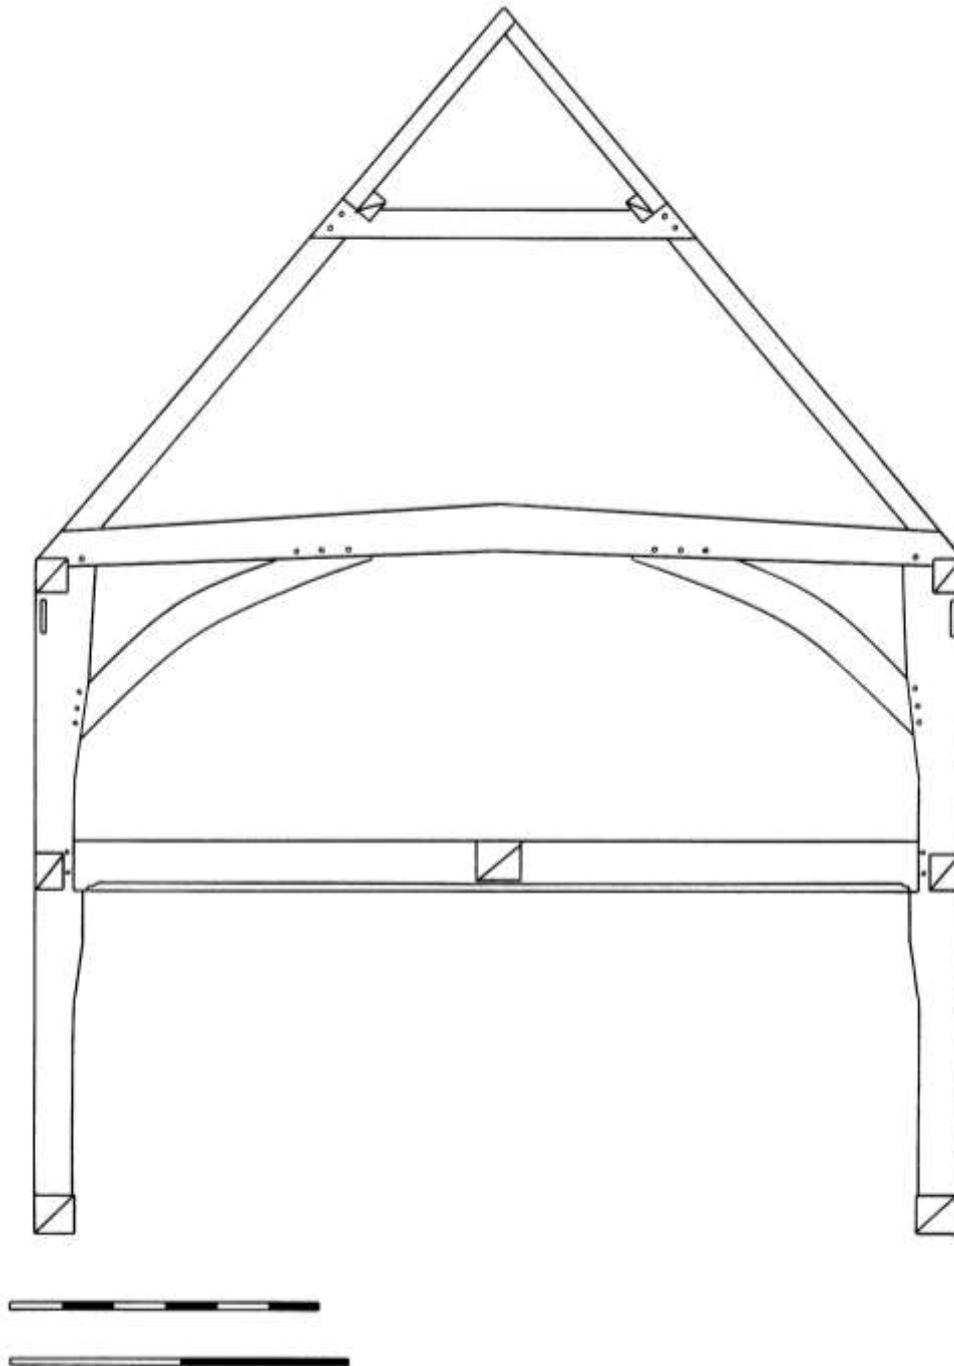
Figure 2 shows the two internal open trusses that flank the bay containing the 20th century entrance door as indicated in figure 1. The ceiling consisted of axial joists tenoned to massive binding joists that measure an impressive 12 inches by 12 and boast deeply chamfered edges with well-formed decorative 'lamb's tongue' stops. In contrast to the binding joists, which remain in excellent condition, the chamfered axial joists have fallen to the ground and have partly decayed; they retain relatively small mortises with diminished shoulders, each measuring 3½ inches in width by 4½ inches in height, for common joists that are conspicuous by their absence and have either decayed entirely or (more probably) been stolen

Reconstruction of the two open trusses flanking the bay that contains the present entrance door (scale in feet (top) and metres). The tie-beams, mid-rails, binding joists, storey posts and roof collars all survive, but the walls are no longer vertical.

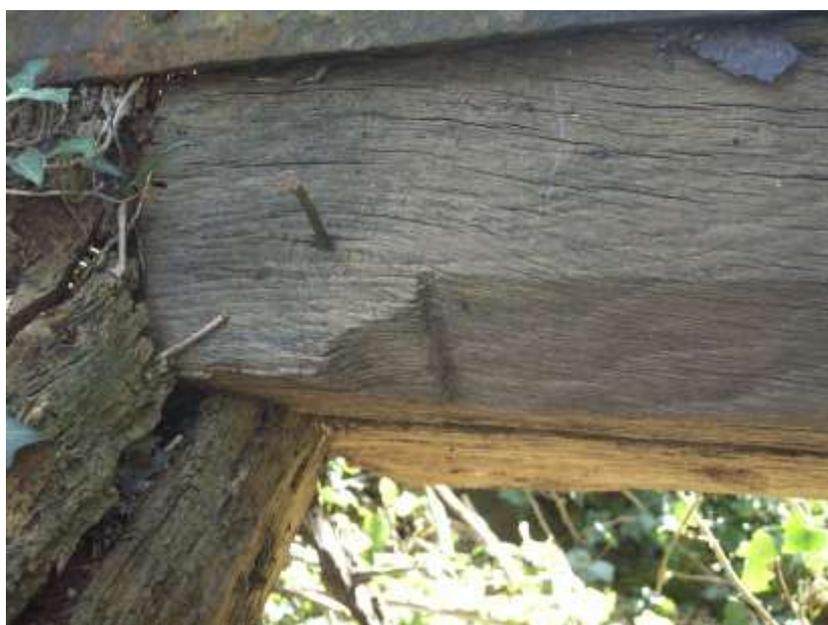
Illus. 6 Detail of distinctive late-16th century chamfer stop to binding joists
