House at Orchard Barn, Ringshall, Suffolk

An Historical Survey

**Leigh Alston MA (Oxon)
Architectural Historian
4 Nayland Road
Bures St Mary
Suffolk CO8 5BX**

March 2007

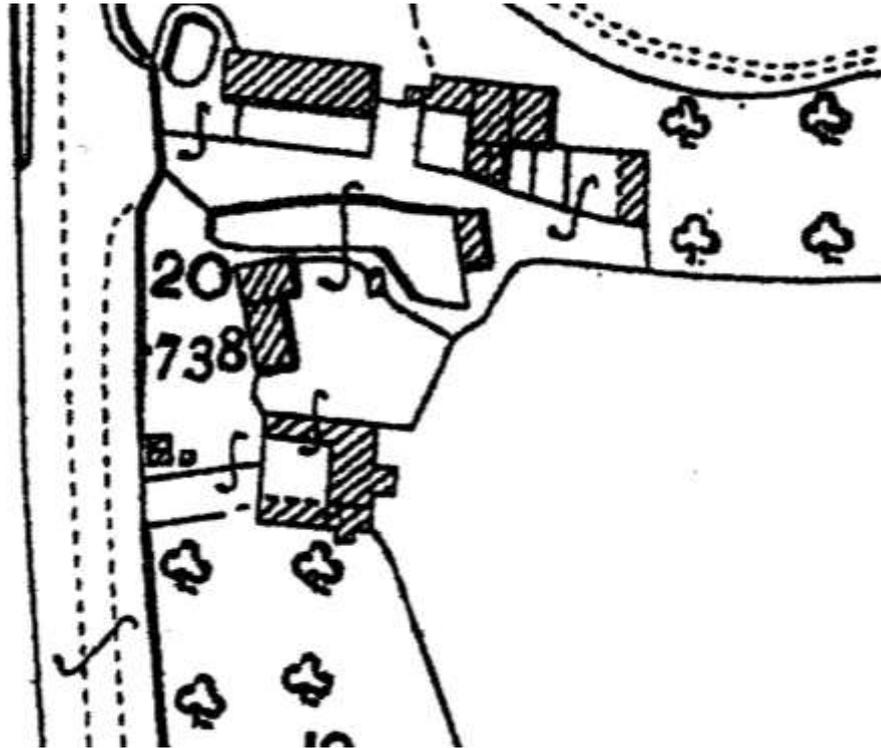
Site Plan (From 25 inch Ordnance Survey 1904)
Showing the house (centre) apparently divided into two cottages with Orchard Barn to the south and Nine Elms Farm beyond the pond to the north.
